Intel® 82571EB/82572EI Ethernet Controller

Specification Update

*January 2012
Revision 6.5*

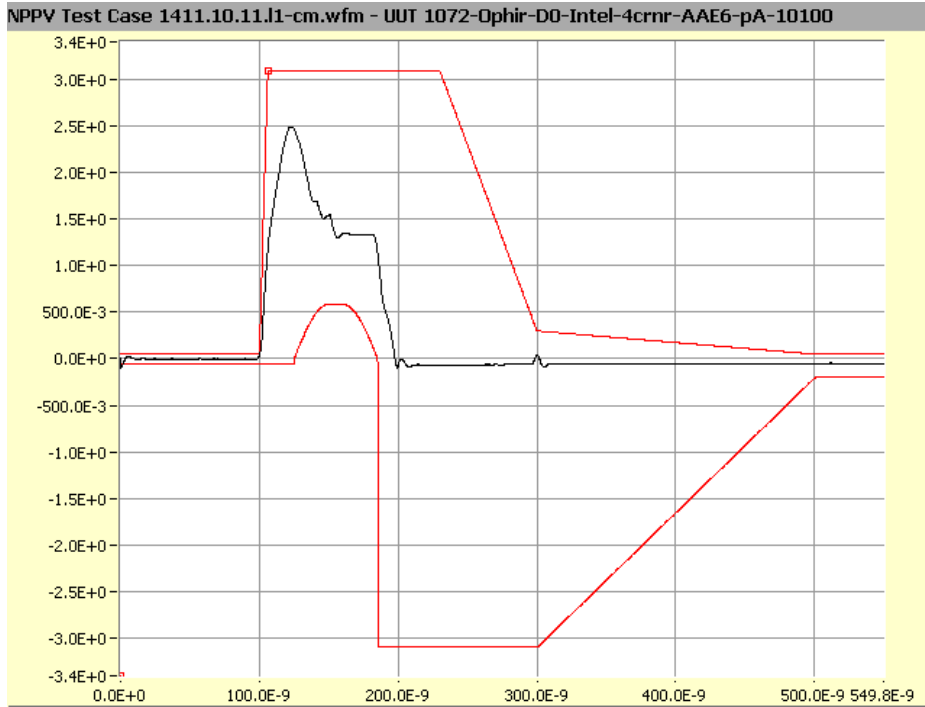
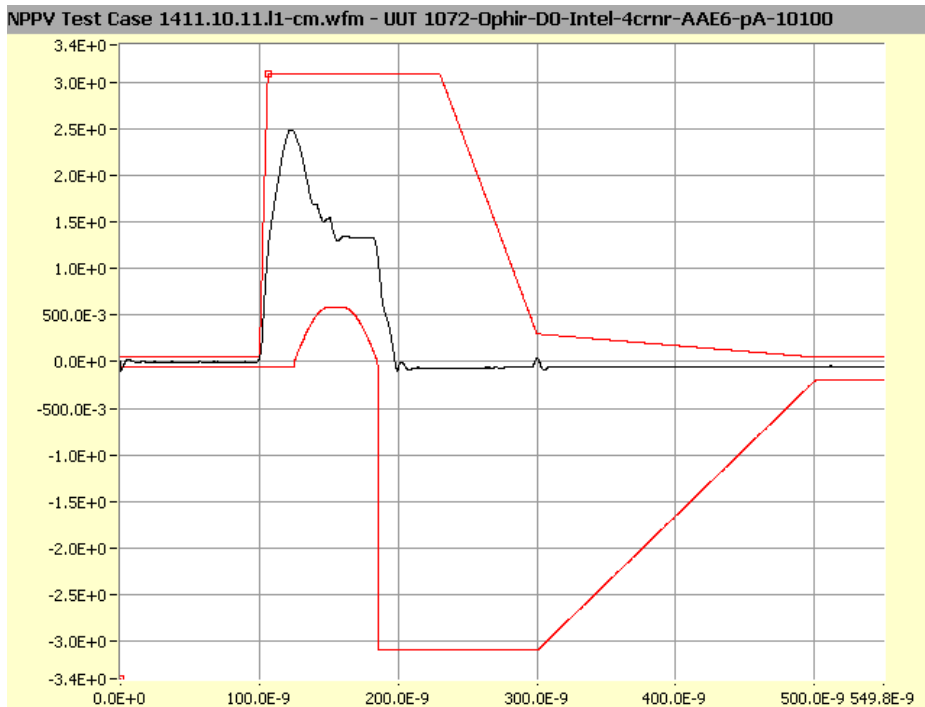
27. 10base-T Link Pulse Hits the Template Mask Due to Voltage Ripple/Glitch

Problem: The 10base-T link pulse touches the template due to voltage ripple/glitch.

Implication: Compliance with the specification is not complete, however, there is no effect at system level.
