Intel® 82571EB/82572EI Ethernet Controller

Specification Update

*January 2012
Revision 6.5*

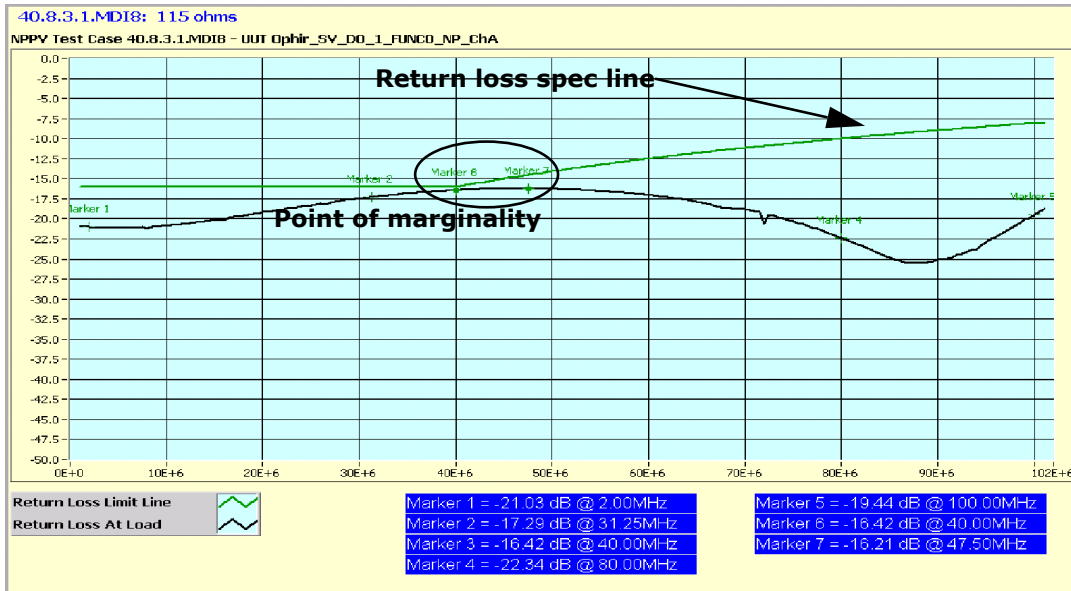
Clarification: Return loss for 115 ohm load is marginal (Gigabit IEEE specification Section 40.8.3.1) near the frequency of 40MHz. Return loss is acceptable throughout the rest of the frequency spectrum and conforms to the 10Base-T and 100Base-TX specification limits.

IEEE conformance is marginal. There is no impact on system-level performance.
